Meadgate School, Chelmsford, Essex

Roofing

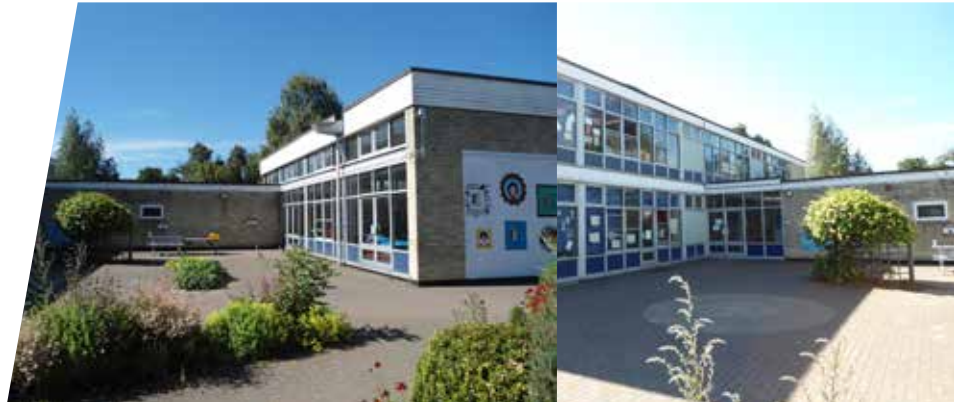
In 2014 Meadgate Primary School had various flat roofs that were coming to the end of their serviceable life. Access to the various roofs required careful planning so as the works that were furthest away from the access point were completed first and in time for the school to be reoccupied. The Main Hall roof required a new roof deck to be installed as this was in a poor condition.

NPS prepared a specification that required the majority of roofs to be over laid in a High Performance Felt over a PIR insulated boards to falls scheme. The main hall area required the whole of the existing roof covering along with the existing defective chipboard decking to be stripped up and replaced. The existing roof decking was replaced with a 25mm CE 2 + rated plywood, laid directly over existing timber firrings, 130mm flat PIR insulation board was installed as there were sufficient falls to this roof. An Esha High Performance Elastomeric Felt Roofing System was installed to these roofs.
