# Collingwood School, South Woodham Ferrers, Essex

## Roofing

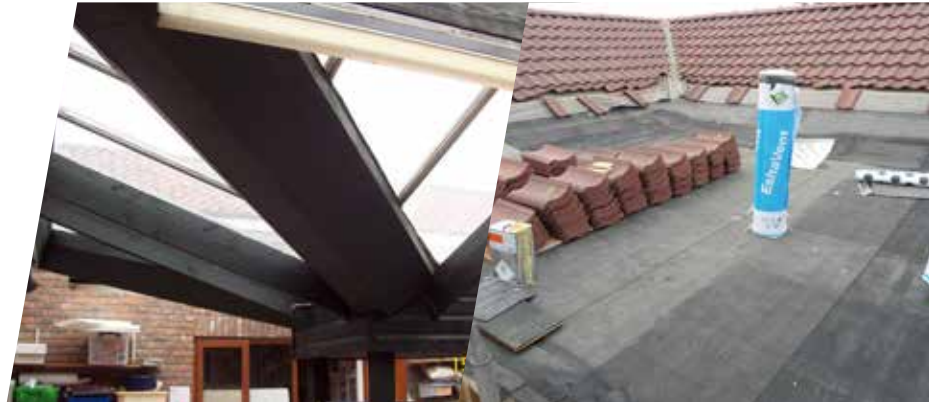
Collingwood School is a primary school located in Essex, we were asked to tender for the renewal of the main pitch roof to the whole of the school. As part of this project we were asked to enclose a glazed quadrangle which was unused by the school. This area suffered extremes of temperature in both the summer and winter months, being extremely cold in the winter and unbearably hot in the summer due to the vast amount of glazing.

The pitched roofing works were straight forward and were undertaken as laid down in the specification. To the perimeter of the Quadrangle was a flat felt roof between the Glazed Quadrangle and tiled pitch roof. This was poorly insulated and the felt was breaking down.

Due to the expanse between each supporting wall and working from a structural engineer's drawings, Kerto laminated beams were to be installed so as to alleviate any columns mid span.

The incorporation of a PIR insulated roof with falls using a Three Layer Esha High Performance Elastomeric Roofing System with a Whitesales Em-Vault Polycarbonate Barrel Vaulted Rooflight measuring 4.7m x 2.4m with access provided using a Bilco Roof Access Hatch.
