Meadgate School, Chelmsford, Essex

Roofing

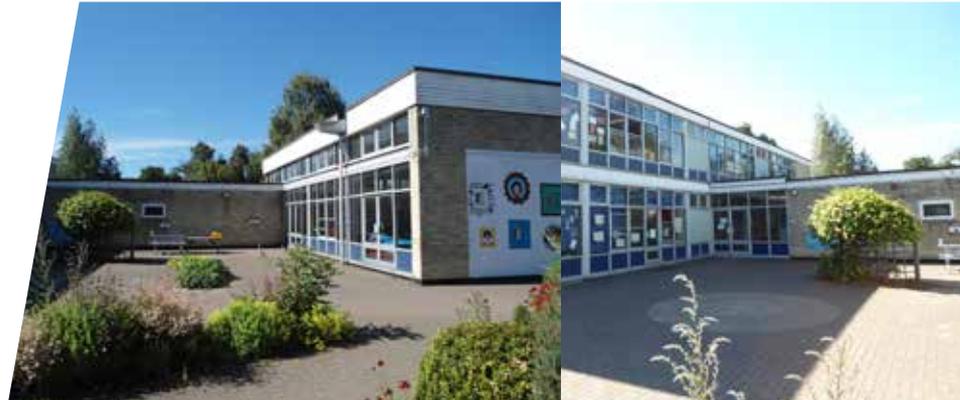
In 2014 Meadgate Primary School had various flat roofs that were coming to the end of their serviceable life. Access to the various roofs required careful planning so as the works that were furthest away from the access point were completed first and in time for the school to be reoccupied. The Main Hall roof required a new roof deck to be installed as this was in a poor condition.

NPS prepared a specification that required most roofs to be over laid in a High Performance Felt over a PIR insulated boards to falls scheme. The main hall area required the whole of the existing roof covering along with the existing defective chipboard decking to be stripped up and replaced. The existing roof decking was replaced with a 25mm CE 2 + rated plywood, laid directly over existing timber firrings, 130mm flat PIR insulation board was installed as there were sufficient falls to this roof. An Esha High Performance Elastomeric Felt Roofing System was installed to these roofs.
